**Architectural and Historical Impact Assessment for the old  
Wesleyan Manse, 3 Mahas Singh Road, Verulam on Lot 206  
Verulam**

Prepared for : Archipod cc  
PO Box 37361  
Overport  
4067  
April 2010

**Architectural and Historical Impact Assessment for the old  
Wesleyan Manse, 3 Mahas Singh Road Verulam, on Lot 206  
Verulam**

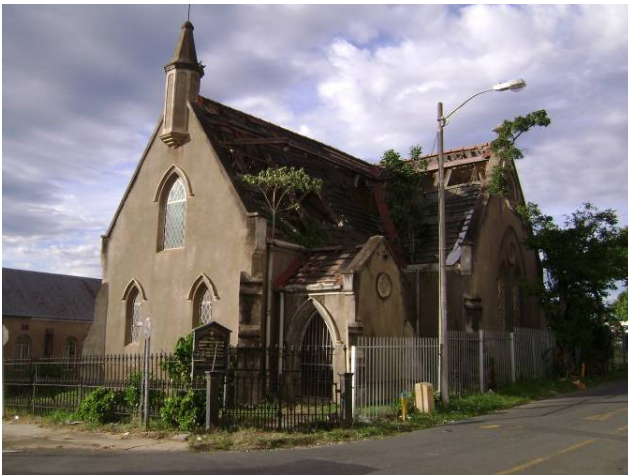
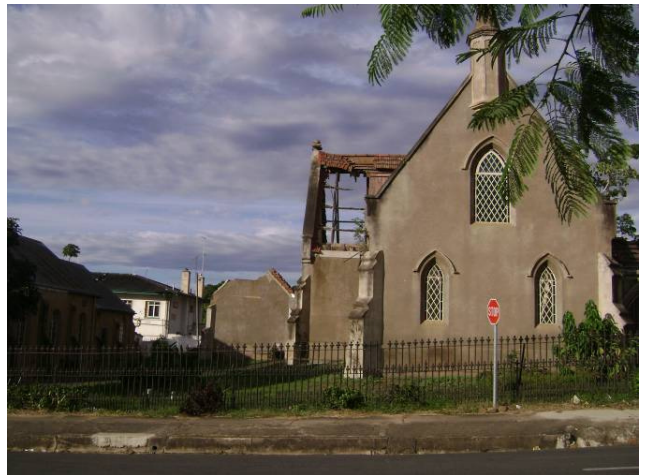
***Figs 1 and 2: the old Wesleyan Church in Groom Street.***

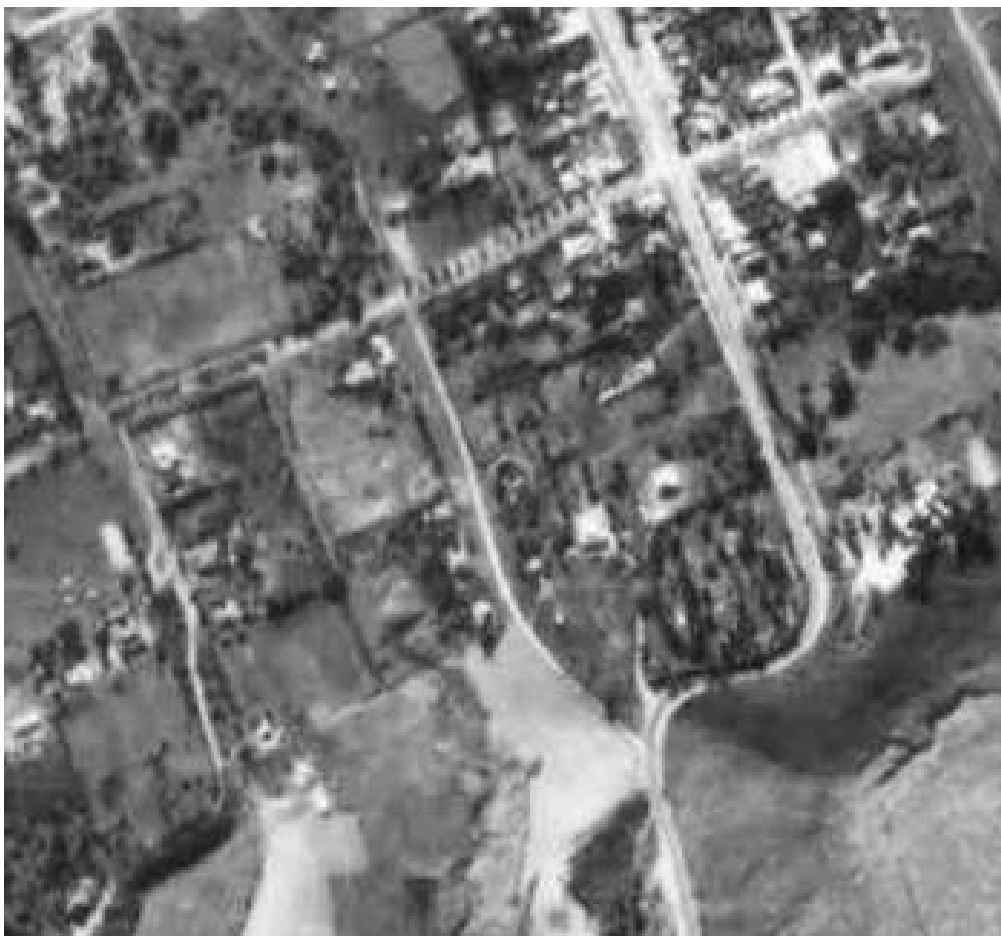
***Fig 3: 1937 aerial photo showing the Manse, the large roof to the left. Note adjoining structure on Lot 205 which has been demolished for apartment buildings. The planting to the graveyard to the south is also prominent and established.***

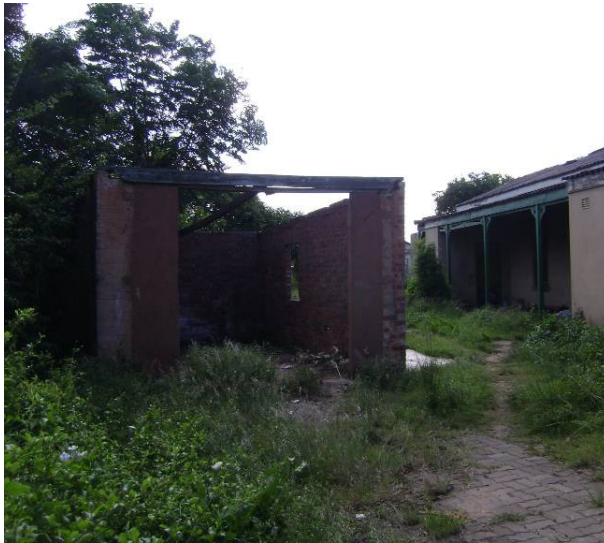
***Figs 15 and 16 : rear of building showing the back veranda and the study to the left, and the ruins of a garage of more recent construction (outbuilding OB2)***

This is a ramshackle shed of recent brick construction. Not much of the mono-pitch corrugated sheeting roof remains.

***It is the opinion of the author that this structure be demolished should the need arise.***

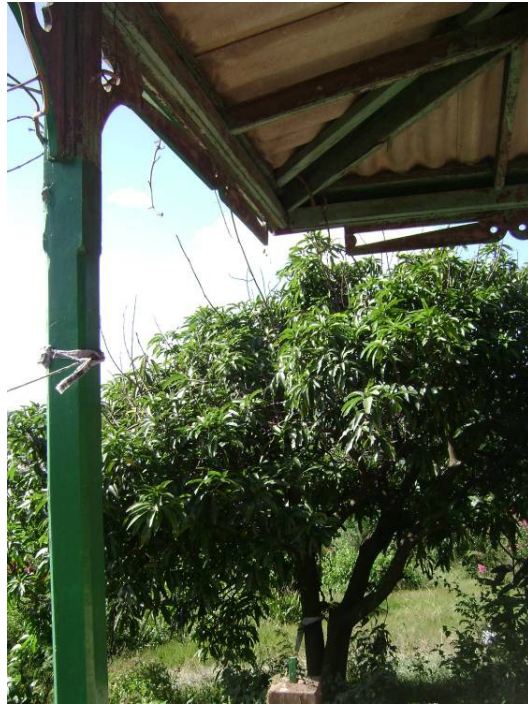
***Fig 22: missing post north east corner***

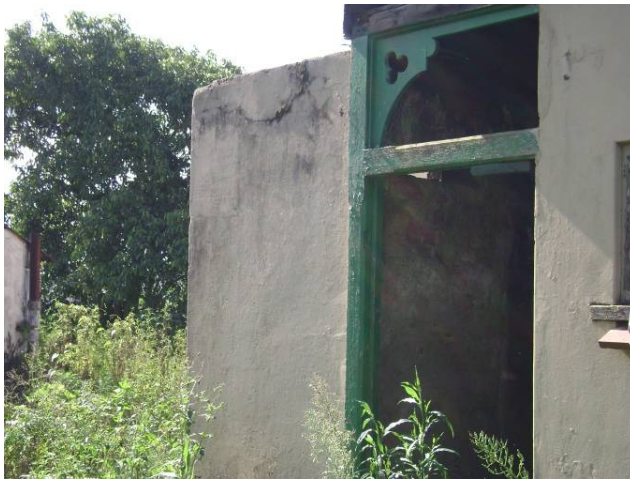
***Fig 27: showing clumsy bathroom conversion at rear***

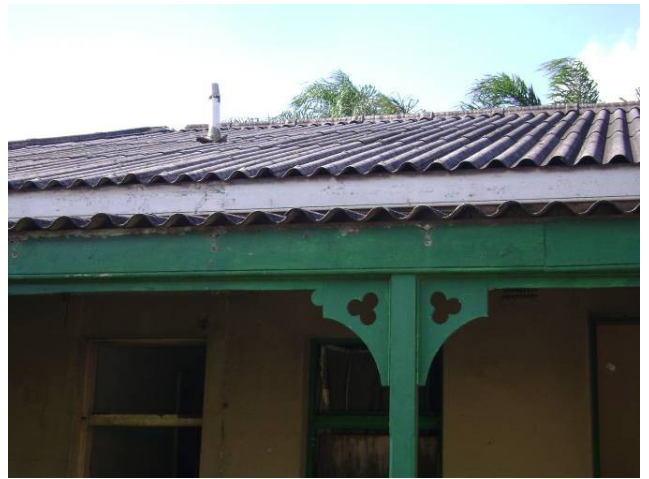
***Fig 28: fibre cement roof, timber***

The main building, the old Manse, is of solid construction, having been built possibly as early as 1864 when the land alienation occurred. Certainly the fibre- cement sheeting to the roof is a more recent addition, replacing, given the pitch of the roof, what would have been a corrugated iron roof. It is a good example of a veranda style house typical of its period, and of which there are many similar in a more protected and credible location.

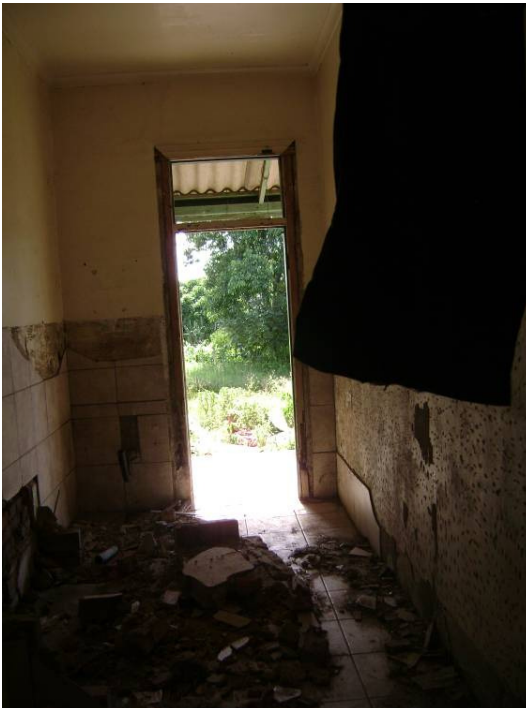
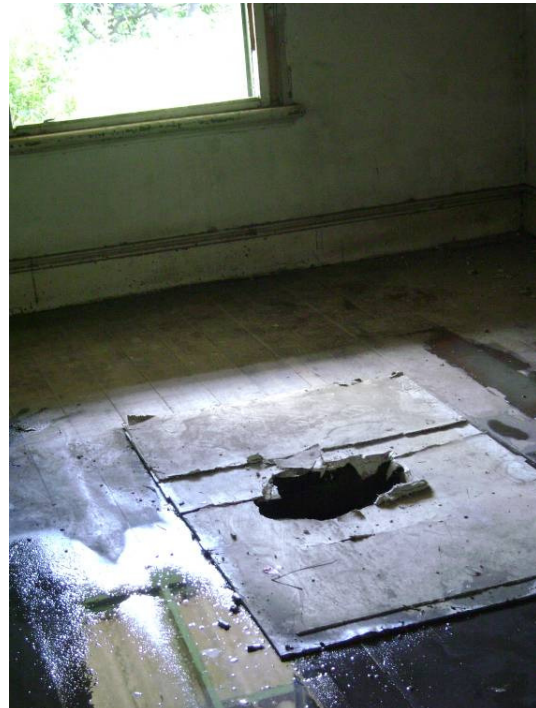
***Fig 31: view through bathroom (room 10) to veranda Fig 32: makeshift toilet in room 11***

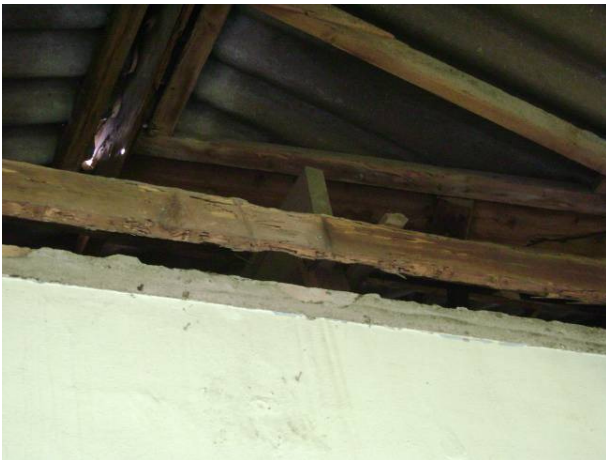
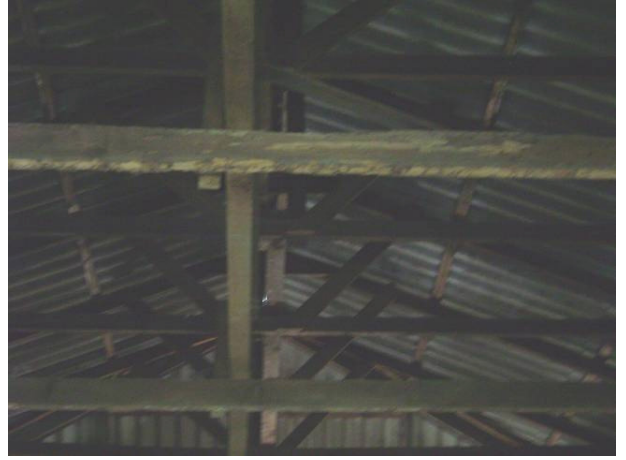
***Figs 35 and 36: ceiling space showing damaged timbers and removed ceilings***

Much of the degradation to the building is through neglect, and its current inhabitants, albeit transitory, have possibly assisted in further demolition through the removal of doors, windows and ceilings for firewood, and modifying the structure to make it usable for them in their current circumstances. The transient nature of these inhabitants is cause for concern in the neighbourhood, as this building, with its total lack of continuous occupation, is described as being problematic by the neighbour running a panel beating business, noting the building as a den for thieves and criminals.

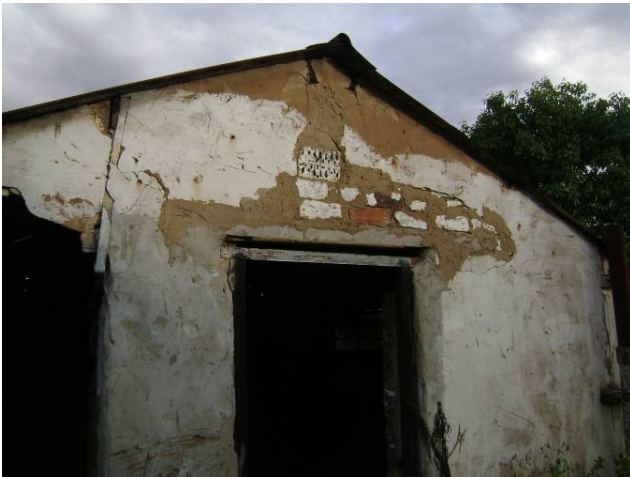
**Fig 39: outbuilding no 1**

Outbuilding 1, evident on the 1937 aerial photograph in Fig 1, is possibly an old coach shed. One half was clearly accommodation, given the fireplace (see fig 39). It is of mixed construction, but primarily brick and mortar.

***It is the opinion of the author that this structure be demolished should the need arise.***

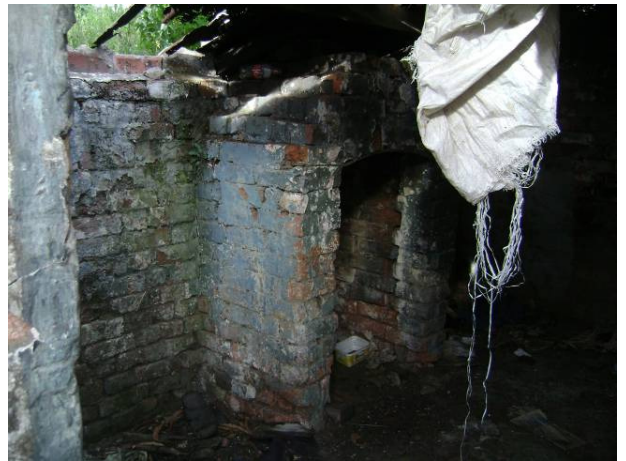
**Fig 40: interior: outbuilding no 1**

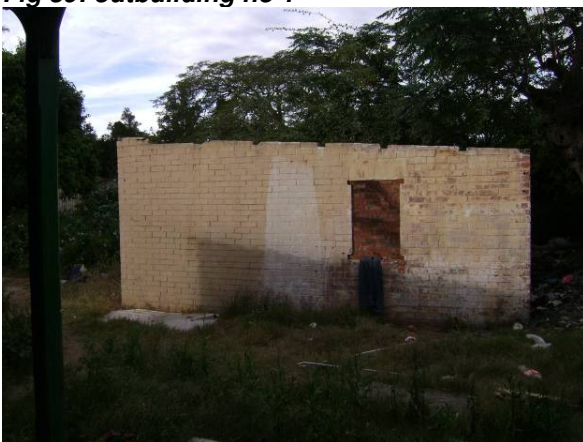
**Fig 41: exterior: outbuilding no 2**
